Dolby Laboratories Inc

Field Bulletin 219

Models CP500 and DA20

Intermittent Cat. No. 671 Failure

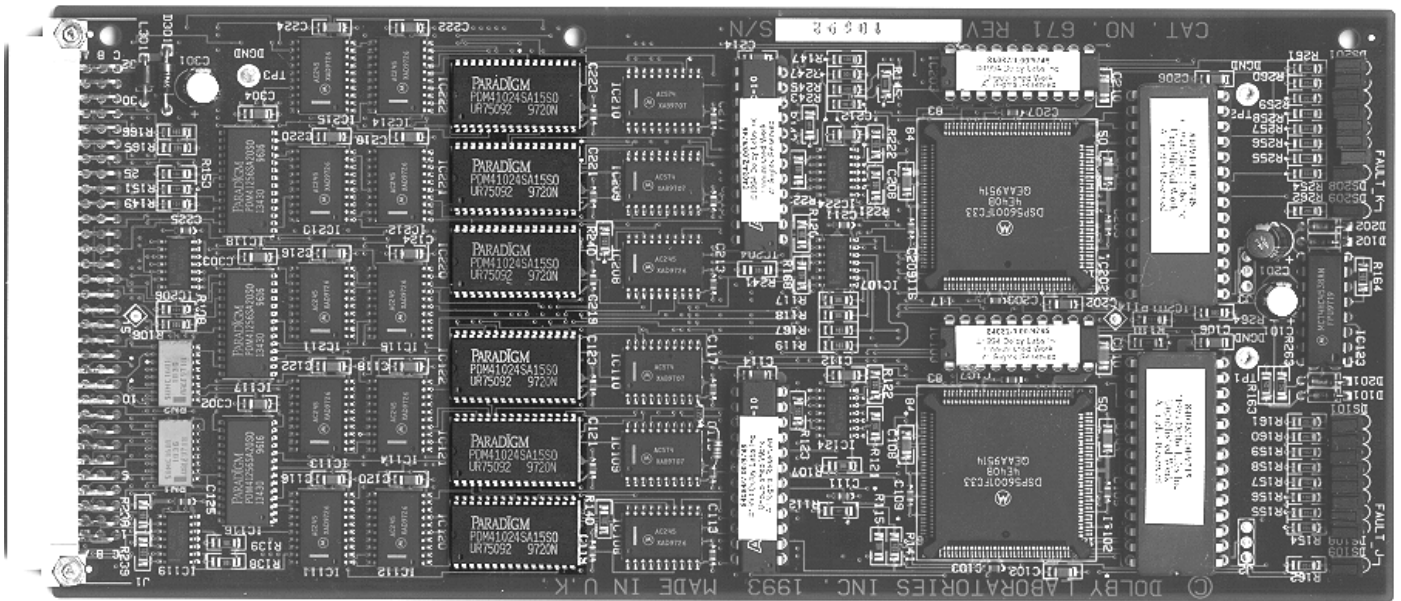
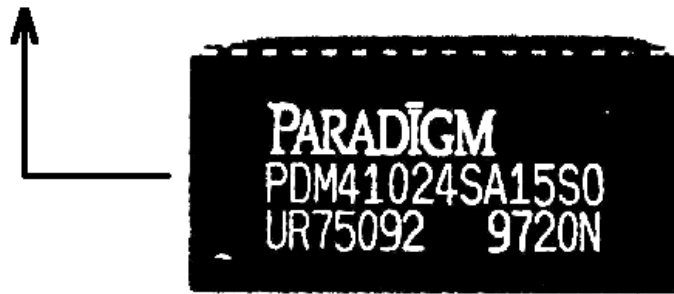
Any Cat. No. 671 board which shows this specific problem and which uses SRAM parts manufactured by PARADIGM with batch code UR75092 and date code 9720N in any of the six locations IC120, IC121, IC122, IC220, IC221 or IC222 should be returned to Dolby Laboratories for replacement.
