Dolby Laboratories Inc

Field Bulletin 223

Models CP500 and DA20

Slow switching to Dolby Digital sound

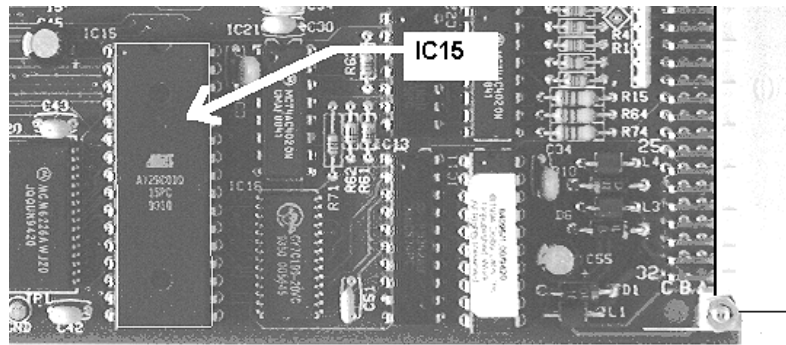
1. Switch off the cinema processor and remove the Cat. 673(A) card.
2. Locate IC15. Note the orientation of the IC.

3. Be sure that your wrist strap is adequately grounded and gently remove IC15 from its socket using an IC extractor tool.
4. Install the new IC15 in the socket. Be sure that no pins are bent and that all pins fit into the socket holes.
5. Reinstall the card in the processor.
