Dolby Laboratories Inc

Field Bulletin 222

CP65 with DA20

Incorrect Wake-up Format after Power-up

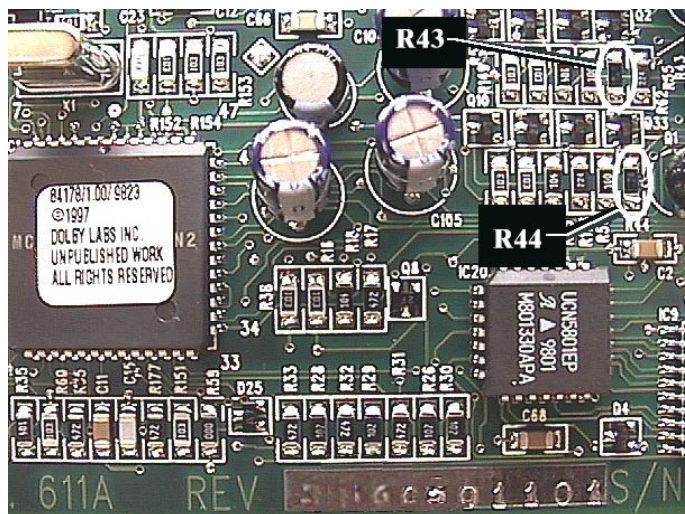
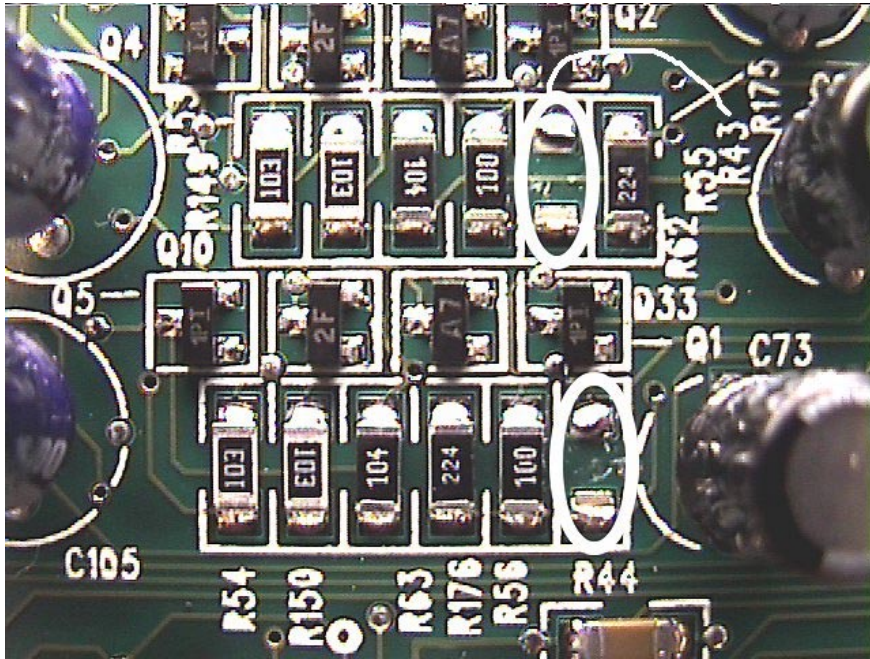
A section of the Cat. No. 611A circuit in the DA20 does not stabilize until **after** the wake-up pulse from the CP65 is received. This causes the Cat. No. 611A to issue an arbitrary format 04 or 05 pulse.

1. Shut off the power to the DA20.
2. Remove the 12 front panel mounting screws.
3. Remove the Cat. No. 611A card from the last right-hand slot.
4. Referring to the figures below, locate resistors R43 and R44.

- Using a small sharp-pointed cutter located at the center portion of the resistor body, shatter each resistor. The resistors should break away cleanly and leave no connections. **Use care to prevent the cutter's sharp tips from damaging any traces on the board beneath the resistors.**

Do not use a soldering iron. A hot soldering iron can damage the surrounding surface-mounted components or PC board traces.
